Correcting For The Unexpected: Dead Anodes, Glitches, Hotspots And Gain Drift in JEM-X Data Processing

ABSTRACT: Since launch the JEM-X units have developed a number of unexpected effects which have been observed in the science data. This is especially true for JEM-X2 which has been in constant use since the switch on of the high voltage supply in October 2002. These anomalies have to be detected and corrected automatically in the ISDC processing using the Instrument Specific Software (ISSW). The design of the ISSW made allowance for such corrections, which are implemented through correction tables, instrument characteristics, event flagging and selection, and performance monitoring. We discuss the various strategies for dealing with dead anodes, gain glitches hot spots and gain drift. It would appear that all these problems stem from unexpectedly damaging cosmic ray interactions with the microstrip plates and detector gas. While these effects are beyond our control, the JEM-X experience should benefit future space-based missions using microstrip technology.

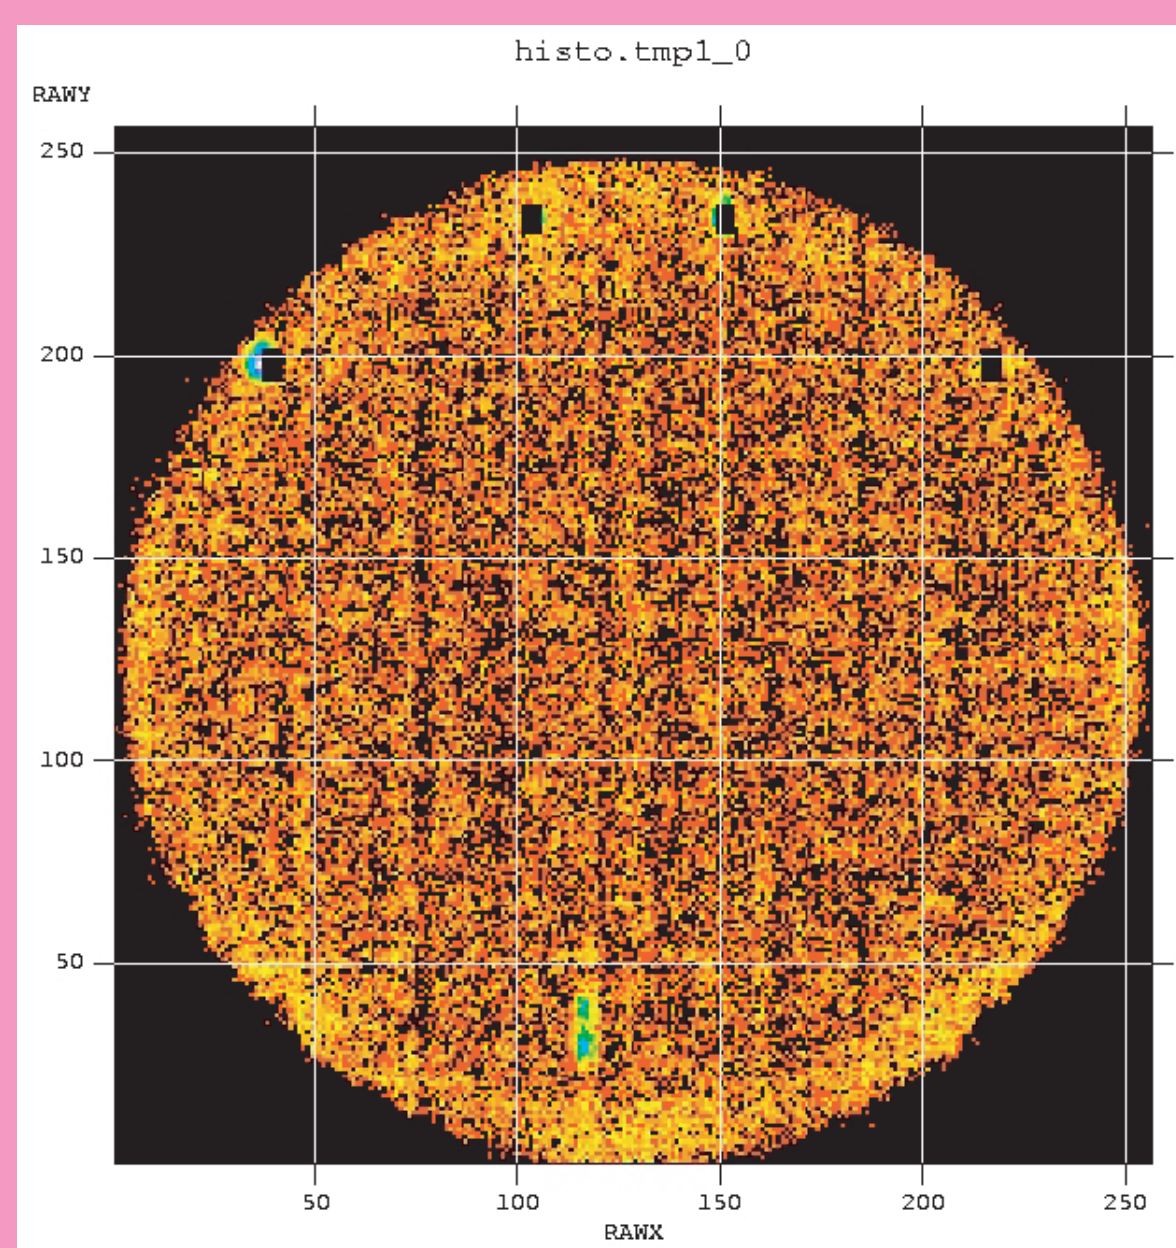
Figure 1: JEM-X1 hotspot, rev. 20

Transient hotspots can occur on the microstrip detectors, though usually in one particular place. A good example was seen on JEM-X1 at the beginning of Revolution 20 (fig.1), apparently caused by some event during passage through the radiation belts. Its strength fluctuated on a time scale of minutes (fig.2) in individual Science windows and from SCW to SCW for several hours. Events originating in the hotspot region are flagged to be ignored during processing, as indicated on the detector characteristics map (fig 6). These 'events' are easily detected due to the very low energy signal they produce (fig 3)

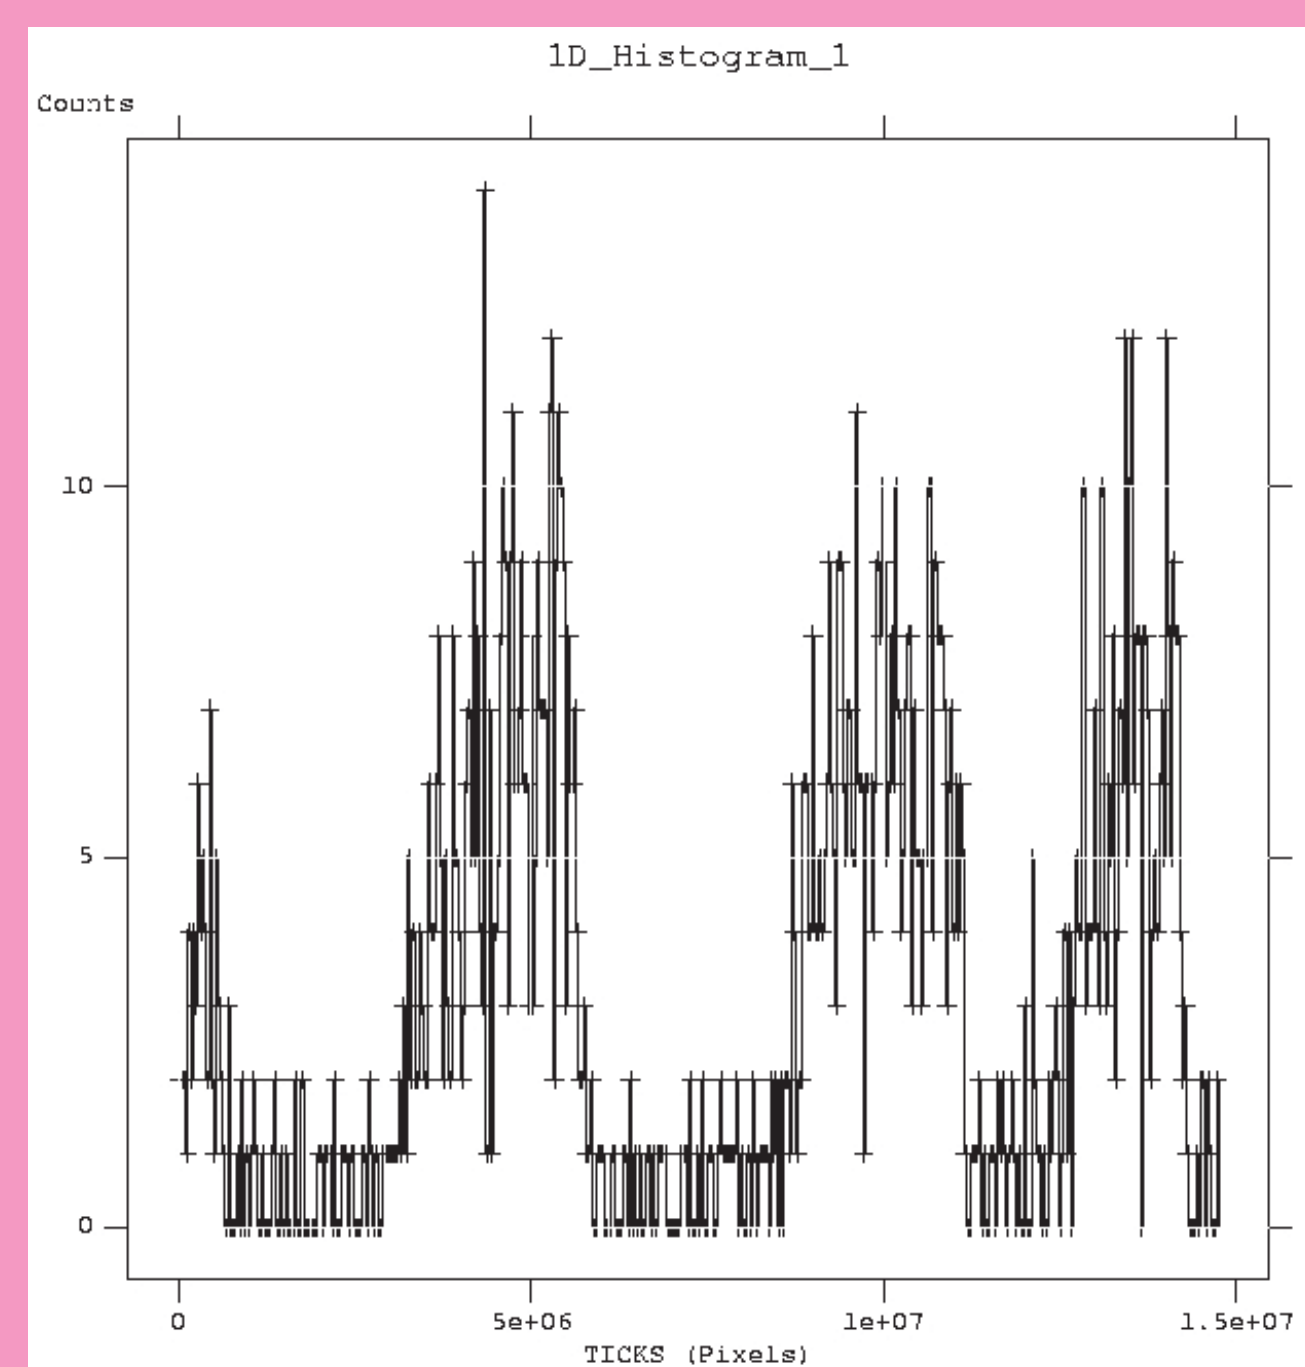
Figure 2: Hotspot strength during first rev. 20 Science Window

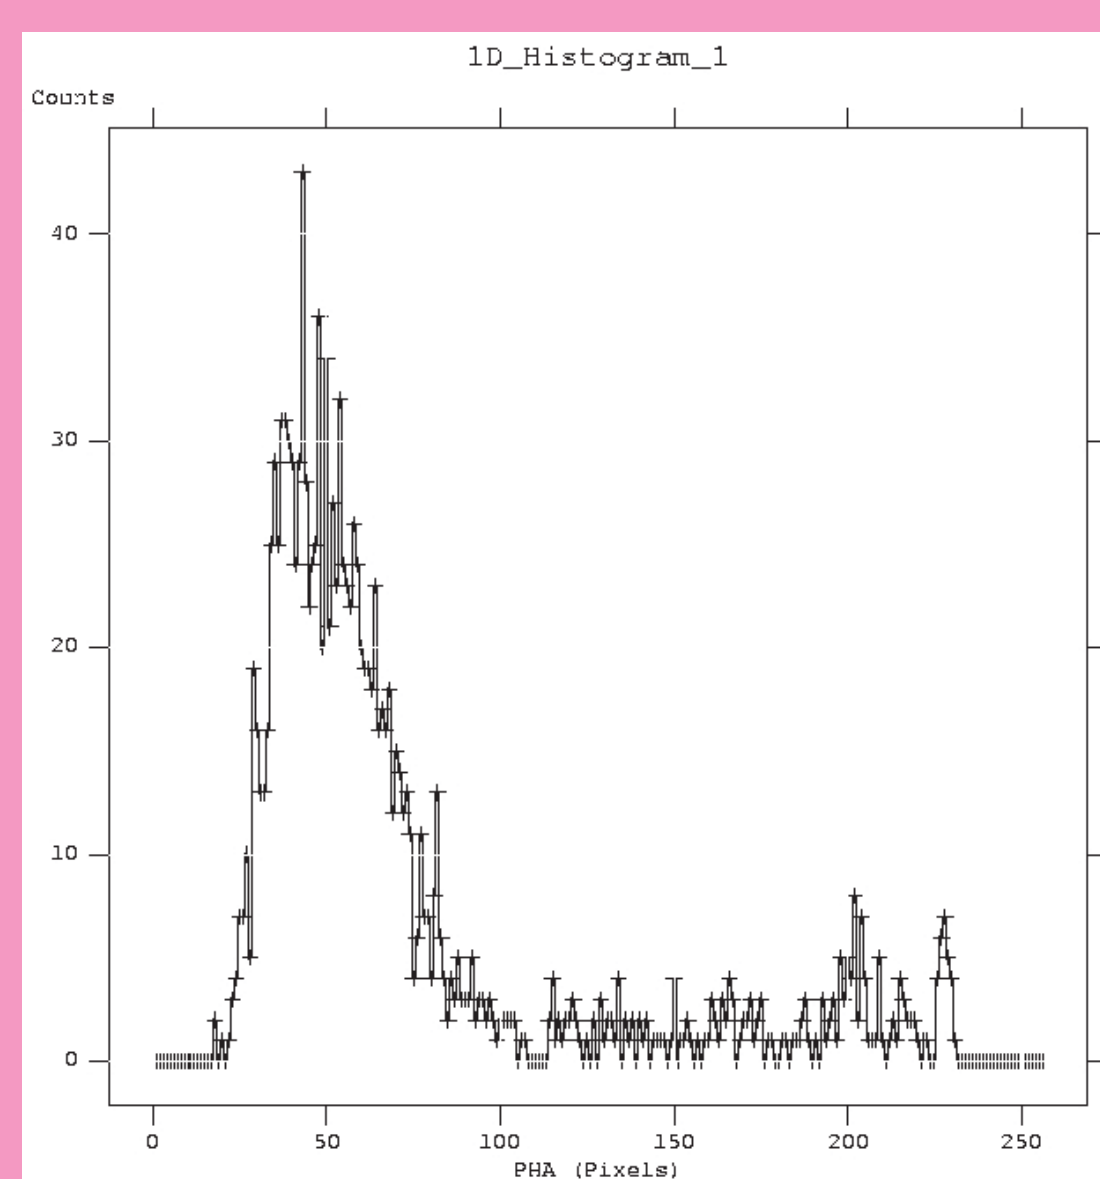
Figure 3: Spectrum of hotspot 'events'

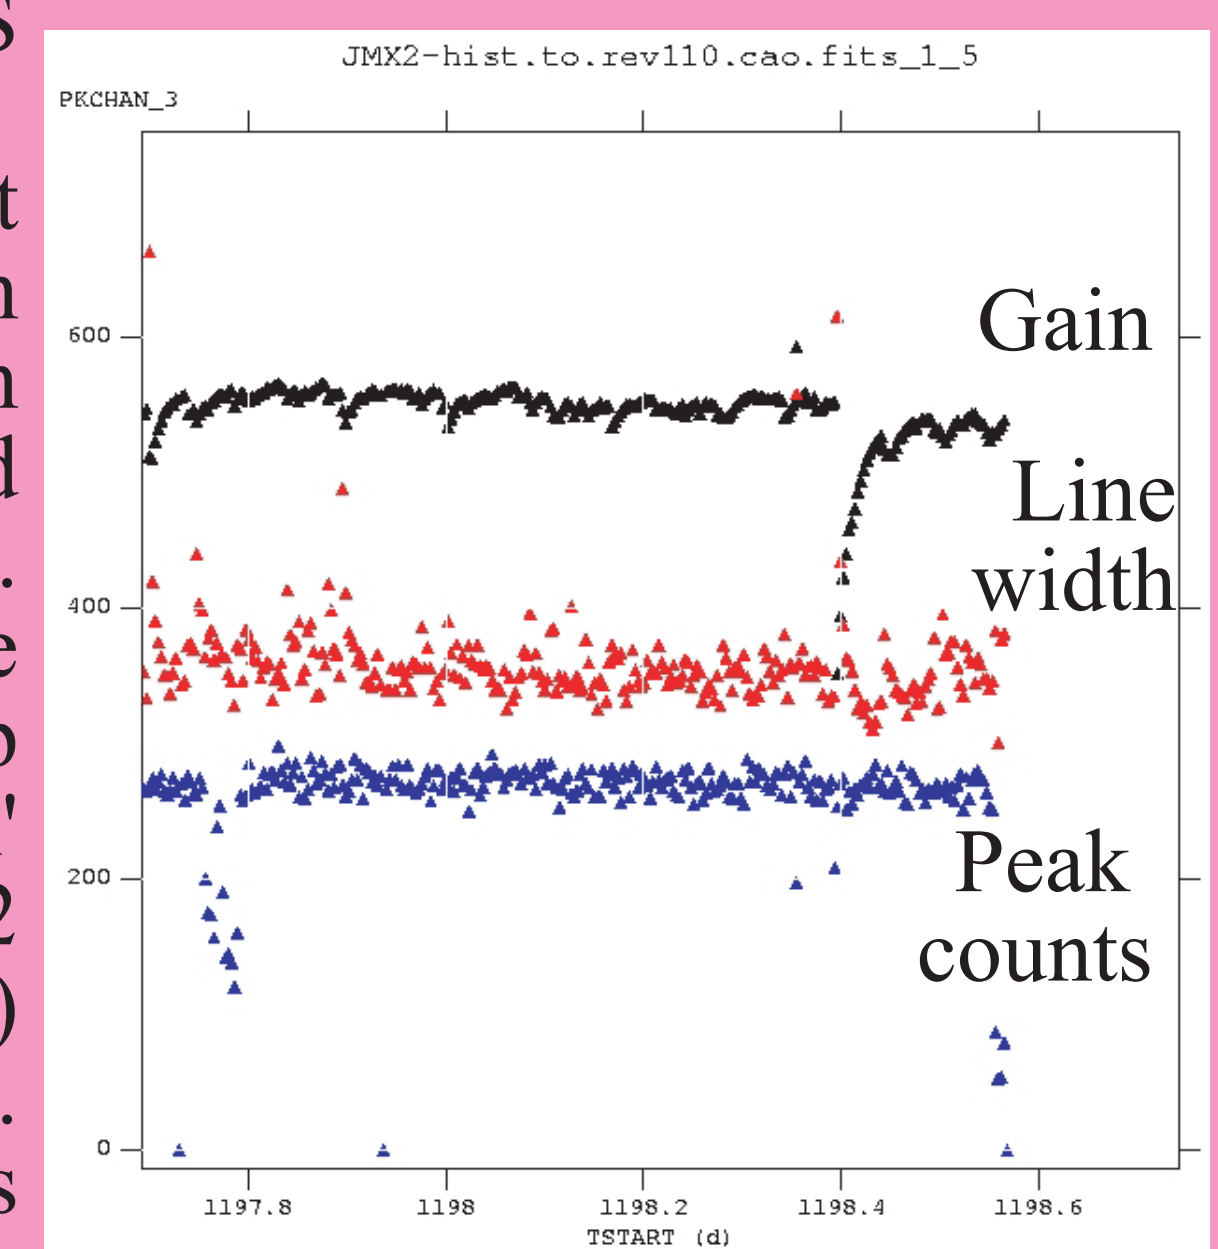
The gain of each unit is determined by the position of the Cd-109 line in calibration spectra. Small, sudden localised drops in gain are common. This is probably due to charging of the microstrip plates by cosmic rays. The biggest 'glitch' so far was on anode 3 of JEM-X2 towards the end of rev. 60 (fig. 4) The gain (black) drops by about 36%. Interestingly, the neighbouring anodes show little or no effect of this dramatic event.

Figure 4: JEM-X 2 gain glitch, rev. 60

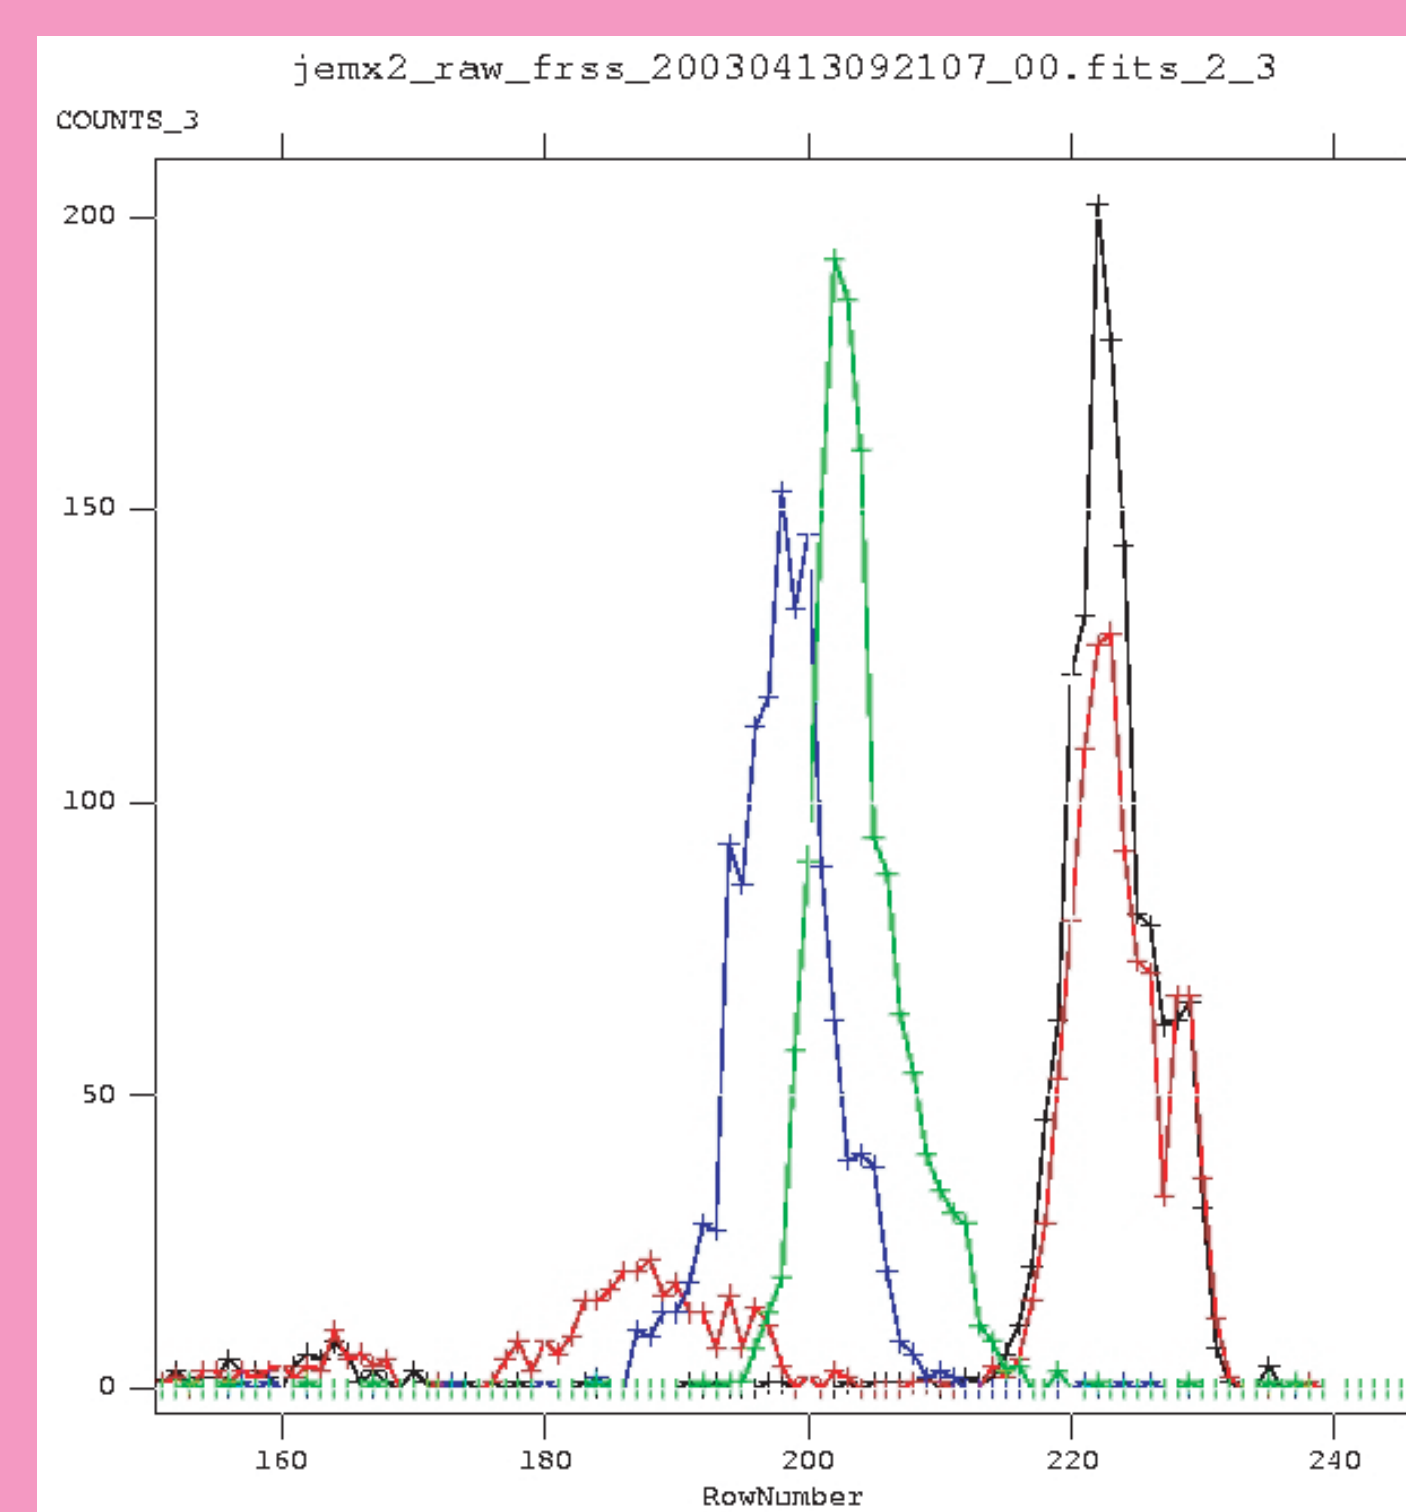
Figure 5: Calibration spectra during the rev. 60 gain glitch

Figure 5 shows the calibration spectra during the glitch. Initially (black) there is high gain and a clear sharp peak showing the Cd-109 doublet. During integration of the next spectrum (red) gain drops, producing a small lower peak. Later spectra (blue, green) show the gain recovering, but are broadened by integrating while gain is varying. Local gain glitches are removed from the calibration data by fitting smooth gain model for each orbit before calculating event energies from the entire detector.

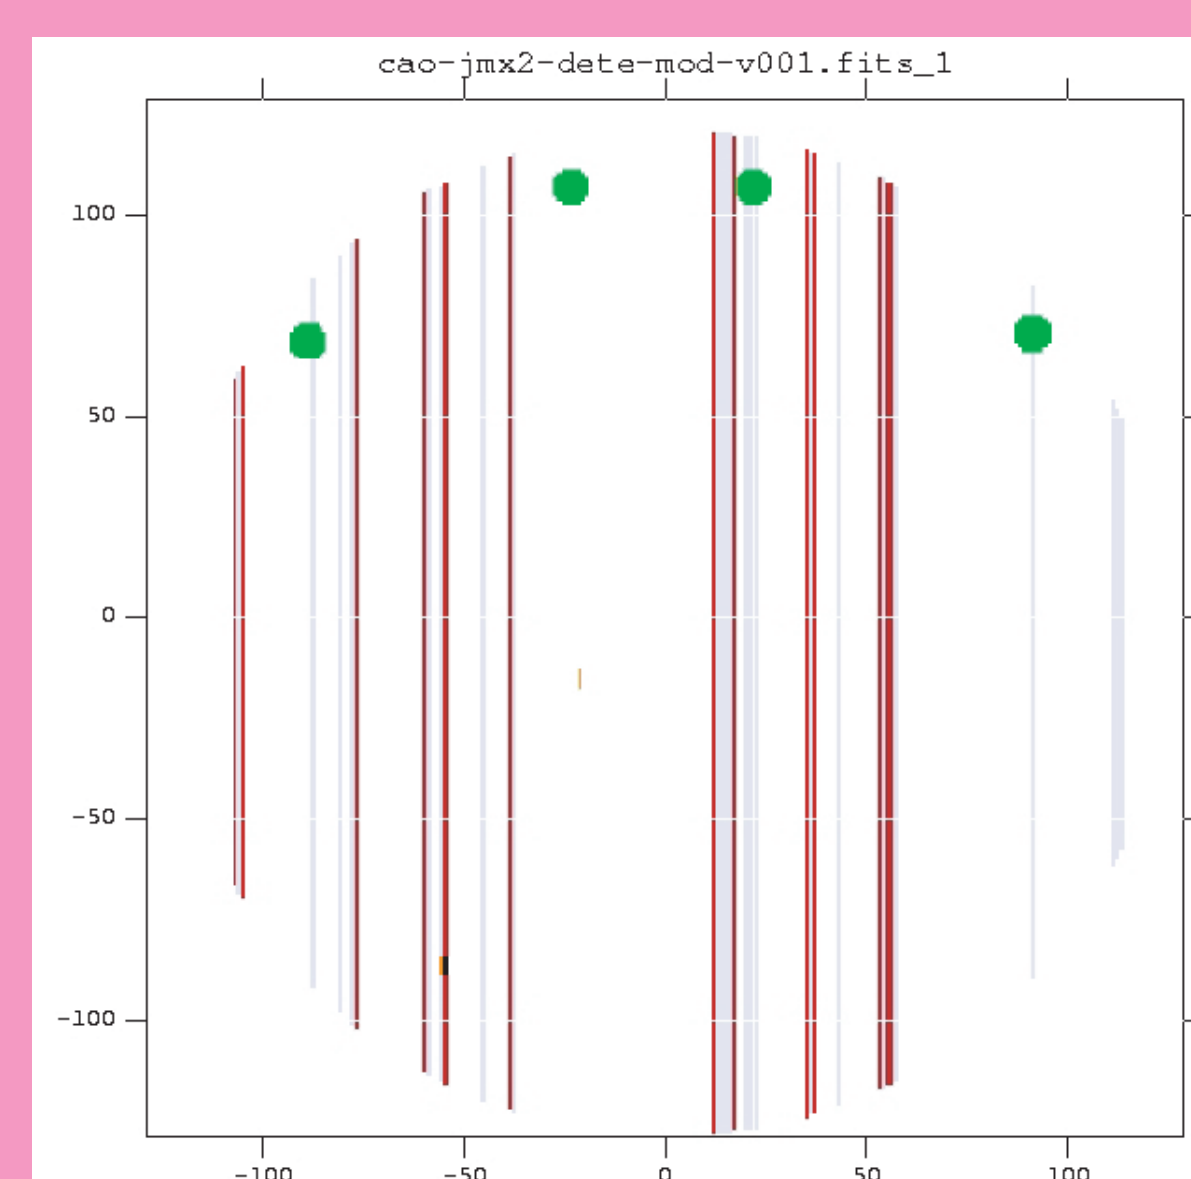
It has been discovered that individual anode strips on the microstrip plates can be damaged, presumably by cosmic rays hitting the fine gold filaments. These dead anodes detect fewer events than normal and these are flagged using the detector characteristics map (fig. 6). A similar map of gain corrections is also used for each anode.

Figure 6: Detector correction map for JEM-X2

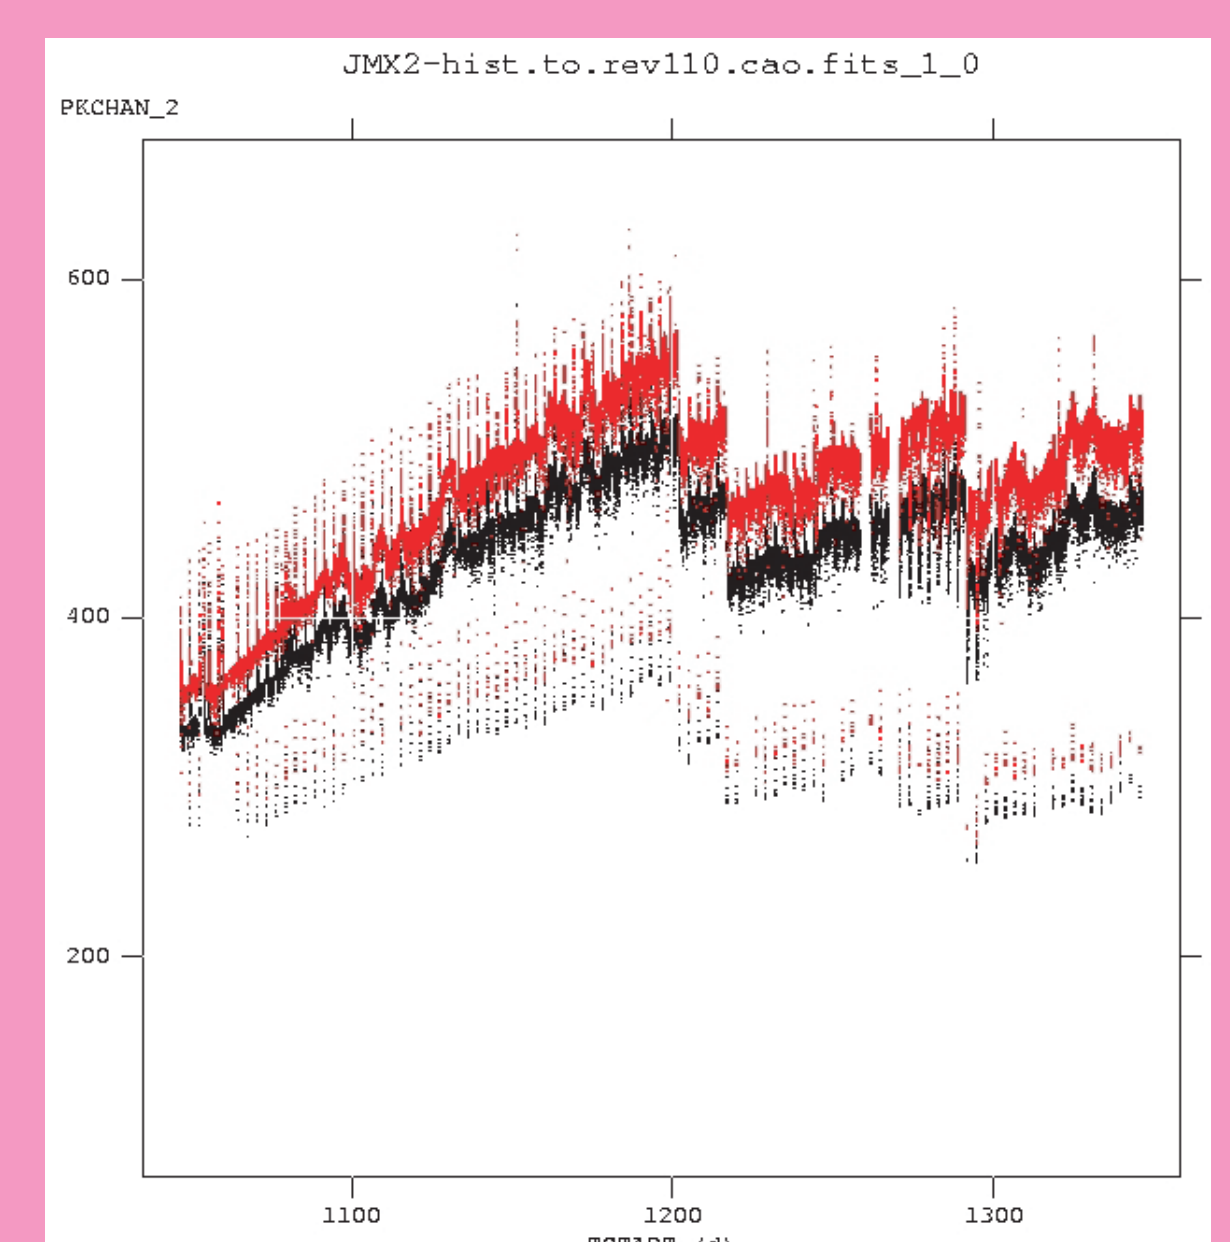
Generally we have corrected data for post launch anomalies. However, the steady gain increase in JEM-X2 can only be solved by decreasing the high voltage on the microstrip plate (figure 7). This has been done so that the Xe lines from the detector gas can be used to monitor detector performance over the plate and to maintain the energy range of the instrument. The cause of this drift is unknown. The quench gas in the detector may be cracked by cosmic ray activity. Damage to the microstrip plate itself could also be the cause of the problem.

Figure 7: JEM-X2 gain on anodes 2 and 3, upto rev. 110
