CORRECTING FOR THE UNEXPECTED: DEAD ANODES, GLITCHES, HOTSPOTS AND GAIN DRIFT IN JEM-X DATA PROCESSING

C.A. Oxborrow¹, N. Lund¹, S. Brandt¹, J. Chenevez¹, C. Budtz-Jørgensen¹, N.J. Westergaard¹, I. Lundgaard Rasmussen¹, and P.Kretschmar²

ABSTRACT

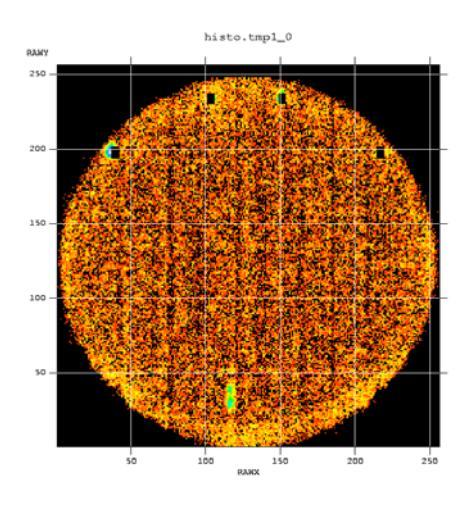
Figure 1. Hotspot seen on JEM-X1 detector at beginning of Revolution 20. Black rectangles along the upper edge are calibration areas.

peared in the JEM-X1 unit after the exit from the radiation belts, at the beginning of Revolution 20 (Fig. 1).

The hotspot problem is dealt with by mapping the affected area in the detector characteristics map JMXi-DETE-MOD. Any events coming from such an area are flagged as undesirable, and software further along the pipeline can remove the flagged events from the processing. OSA 4.0 will contain a more dynamic function whereby events are only flagged if a known hotspot area is deemed to be active.

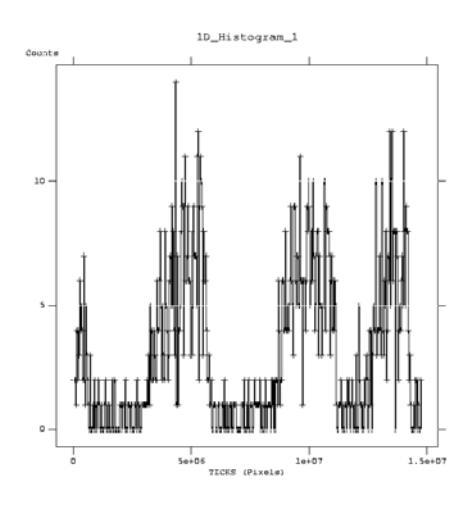
Figure 2. Pulsations observed in Revolution 20 hotspot during the first science window. Counts from hotspot area only.

The hotspot pulsated strongly enough to affect the software trigger rate (Fig. 2) and appeared on and off for at least the next 43 science windows. The figure shows the pulsations seen during a 30 minute science window (00200016001) when the hotspot was active, though some science windows either side of this one show no sign of the hotspot.

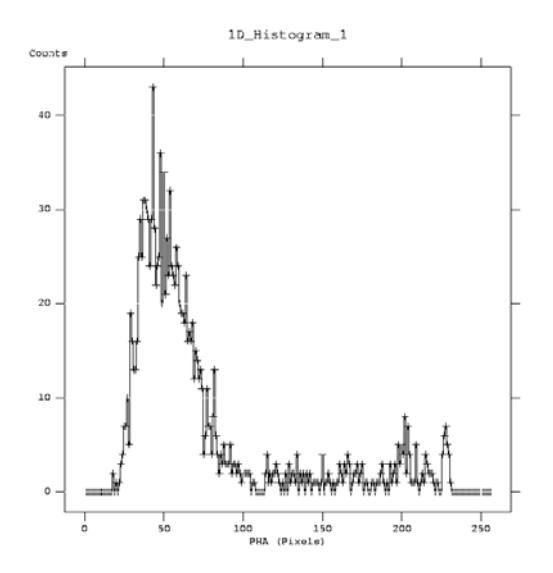
Figure 3. Spectrum of hotspot 'events' from Revolution 20. $PHA50 \approx 4.5 \text{ KeV}$, $PHA100 \approx 9 \text{ KeV}$

The spectrum of 'events' from the hotspot area is very soft indeed (Fig. 3), which probably explains why the spot appears so broad in the shadowgram since position determination is worst at low energies. Hotspots probably arise as a result of plate charging near a 'dead' anode (see below), and all those observed have followed anode strips. What causes the initial charging, and why a spot can pulse, disappear and pulse again are not known. It seems likely that some event in the radiation belts is responsible because there is no sign of this hotspot in the later science windows of Revolution 19. This is probably the result of an energetic particle hitting the microstrip plate near a dead anode.

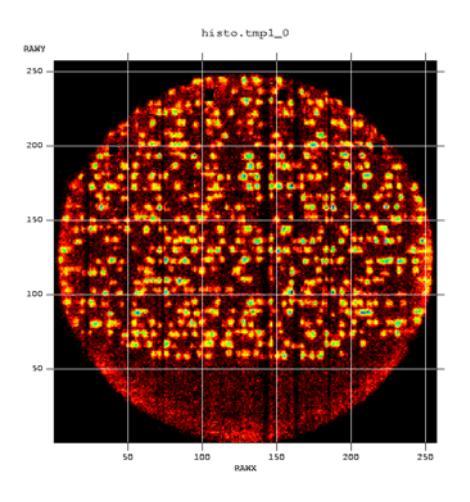
Figure 4. Shadowgram from Crab calibration during Revolution 170, showing effect of dead anodes

Dead anodes appear as vertical strips in the shadowgram with few events (Fig. 4). These are dealt with in two ways. Any events coming from known dead regions are flagged via JMXi-DETE-MOD for removal from the pipeline. The detector gain for every anode position in the data has been determined using the Xe fluoresence line at 30 KeV, so that the energy of each event is corrected according to its x (anode) position using the JMXi-SPAG-MOD spatial gain correction table.

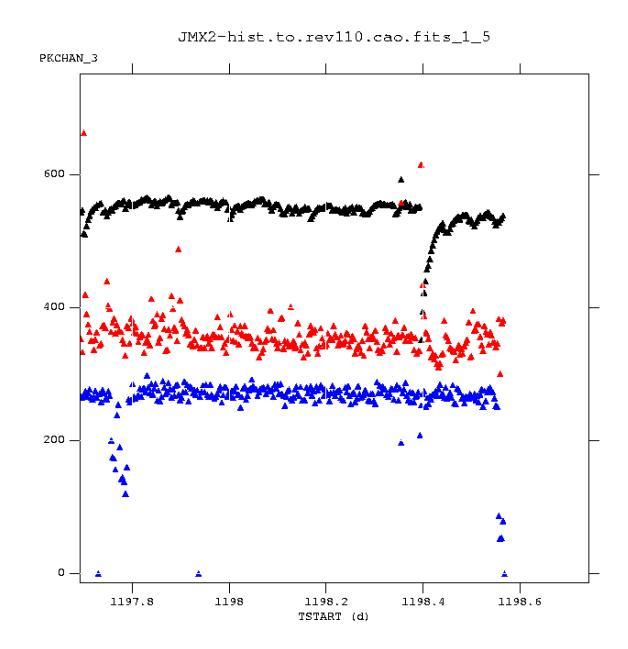
Figure 5. Gain glitch on JEM-X2 anode segment 4 during Revolution 60. Position of 22 KeV line in ADC channels: black; Relative line width: red; Counts in peak: blue

gain of each segment during one revolution is fitted with a time-dependent model that smooths these glitches out so that all our energy calibrations are not affected by glitches near the calibration areas. The biggest of these glitches was seen in Revolution 60, on anode segment 4 of JEM-X2 (Fig 5).

Glitches of a more usual size are also seen in Figure 5. During the big glitch the position of the Cd-109 22 KeV line drops by about 40%. This is quite an extraordinary event, and like the smaller glitches, is caused by localised charging of the plate caused by nuclear interactions with cosmic ray particles. Presumably an especially massive, energetic cosmic ray nucleus caused the very big glitch, which, like the numerous smaller glitches, is not seen in the neighbouring anode segments.

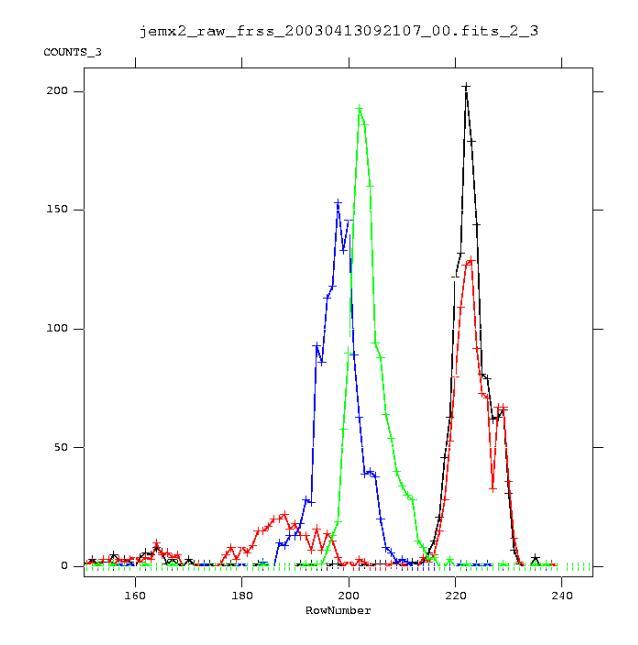
Figure 6. Consecutive calibration spectra during the Revolution 60 glitch event. Order: black, red, blue, green

Looking at the raw calibration spectra (Fig 6), a stable narrow 22 KeV doublet is seen first (black), and for most of the following 4 minutes all is well (upper red peak) but towards the end of the second integration period there is a sudden drop in gain and the peak position drops dramatically (lower red bump). Subsequent spectra show how the gain slowly recovers (blue, green). The later peaks are wider than the original black peak, not because of any intrinsic loss of energy resolution, but because the gain changes significantly during these integration periods. It takes between 1-2 hours for the gain to return to its original value.

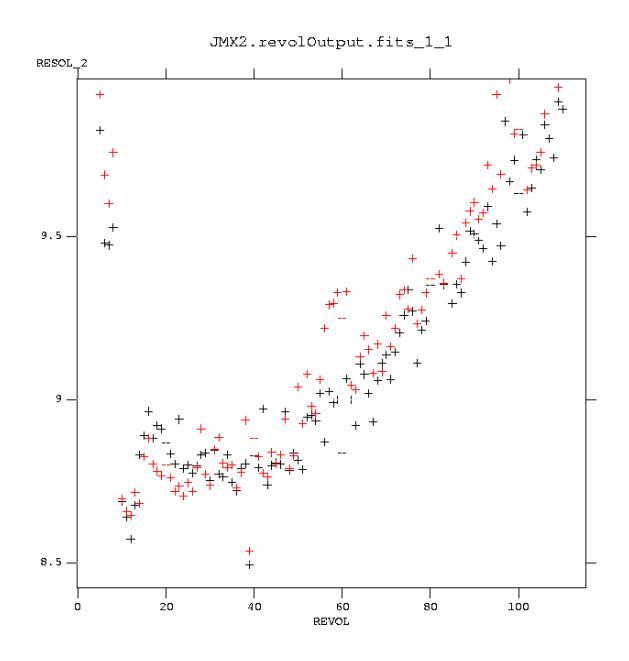
Figure 7. Relative energy resolution in percent for JEM-X2, upto Revolution 110. Each value is averaged over one revolution

JEM-X2 has been in use continuously since October 2002, and during that time the energy resolution has degraded somewhat. Figure 7 shows the percent relative line width of the calibration spectra from the two central anode segments of JEM-X2 from launch to Revolution 110. Each data point is averaged over one revolution. It should be noted that this increase in line widths is small compared to the variation in line widths seen for individual calibration spectra.

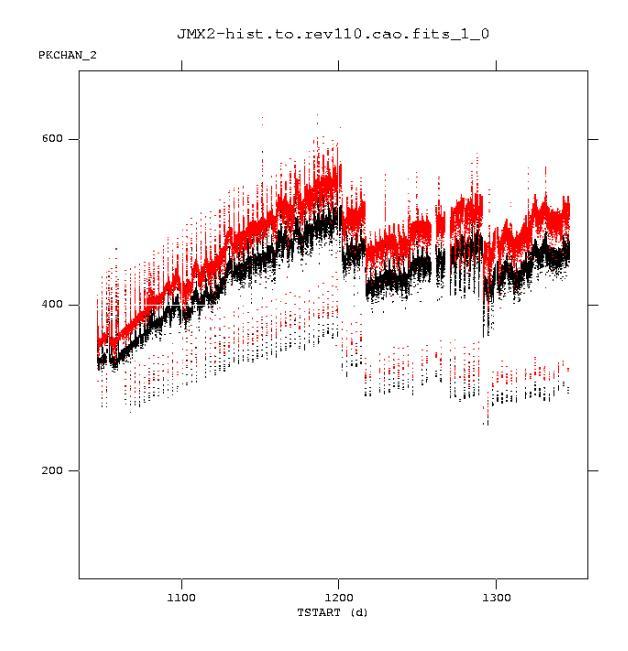
Figure 8. Position of the 22KeV Cd-109 calibration line in ADC channels for anode segments 2(black) and 3(red) of JEM-X2, from launch up to Revolution 110

One of the most striking characteristics of JEM-X2 has been the steady increase in gain observed from the beginning of the mission (Fig. 8). While it has been easy to correct the energy values of the events for this drift, its has been necessary to control the increase by decreasing the high voltage supply to JEM-X2. This is to ensure that the instrument maintains optimum performance within its most sensitive energy range, and so that the 30 KeV Xe fluorescence line used for gain checking can still be seen. Sudden drops in gain on Figure 8 show where the HV has been stepped down.
